Cornell University
Laboratory for Elementary-Particle Physics

Experimentally Observed Defects in Niobium SCRF Cavities Tested at Cornell

Zachary A. Conway

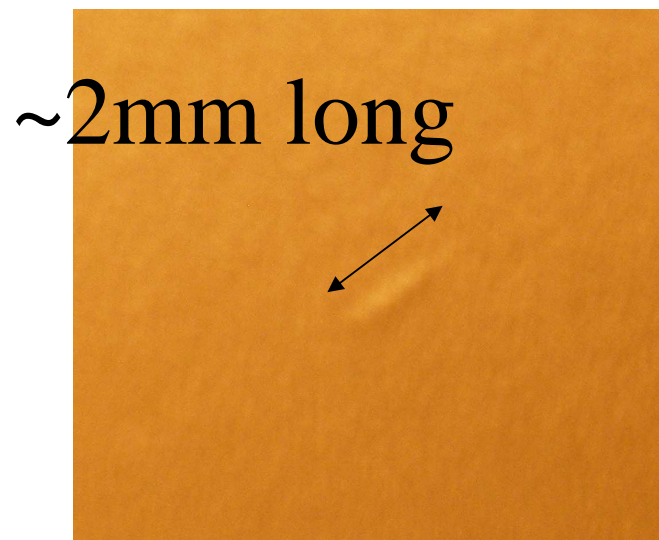
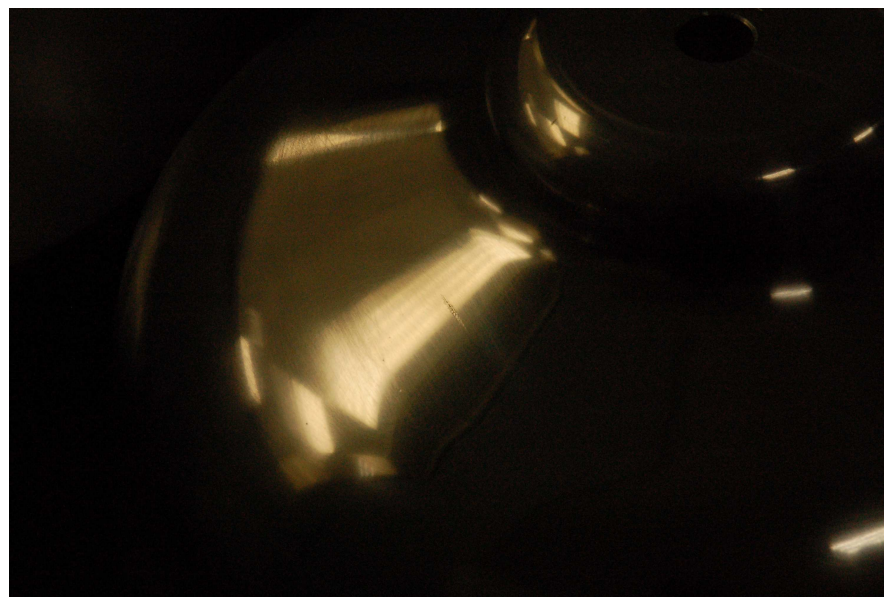
- Two cavities tested last year quenched but the defect was not located on the equator EBW or the iris.

- An additional 100 μm BCP etch of these 2 cavities “fixed” this defect.
- Equator EBW defects were then encountered which limited the maximum achievable surface fields.

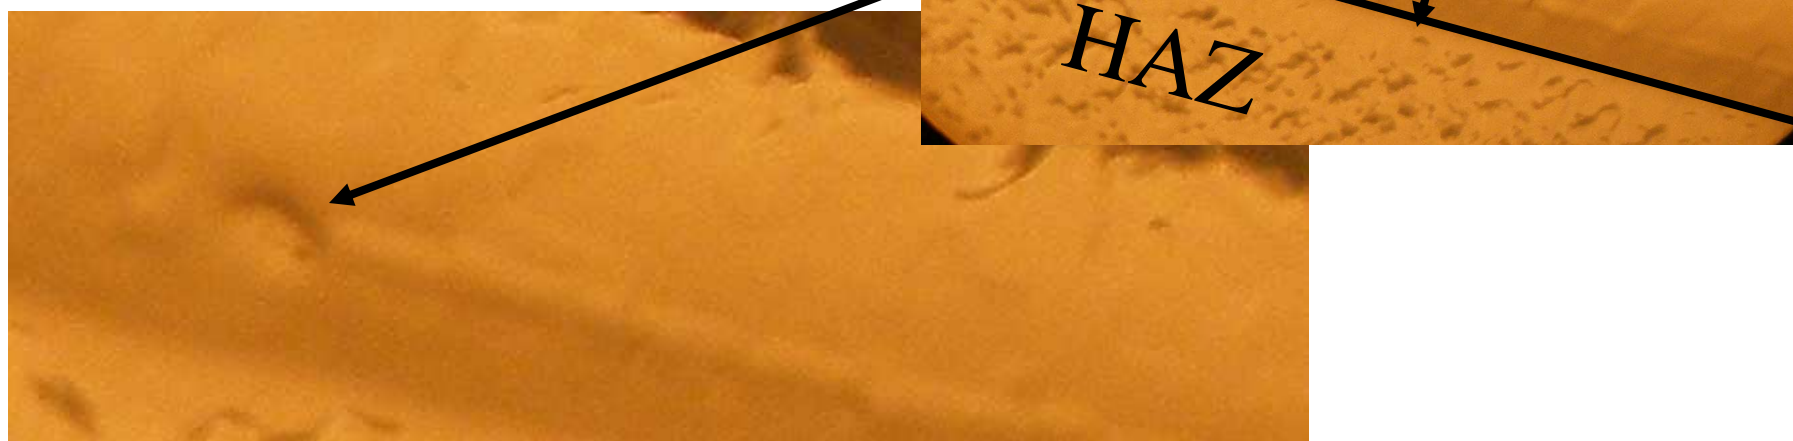
Equator EBW Defects

- Pit with protruding line...
- Origins of feature unknown.
- Removed with tumbling.
- Further testing in the next two months.

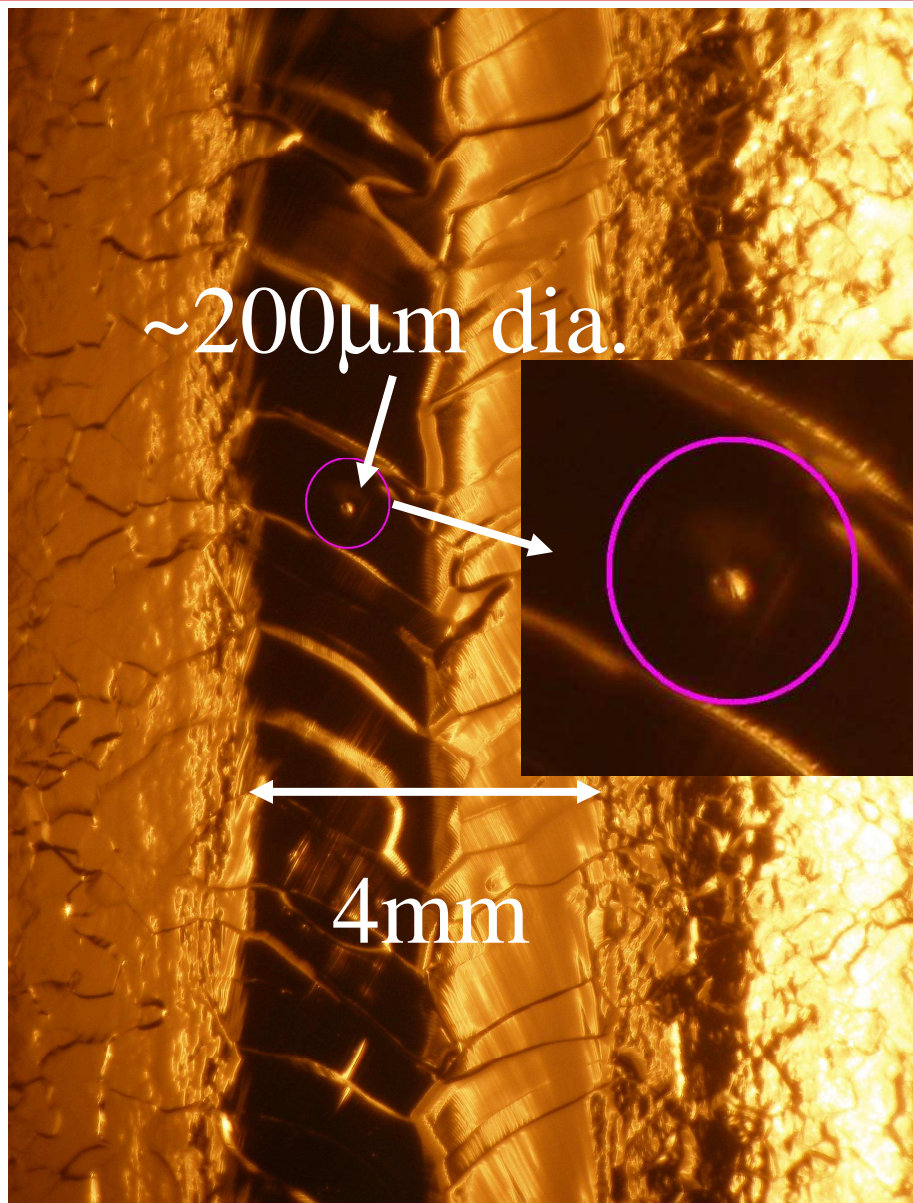
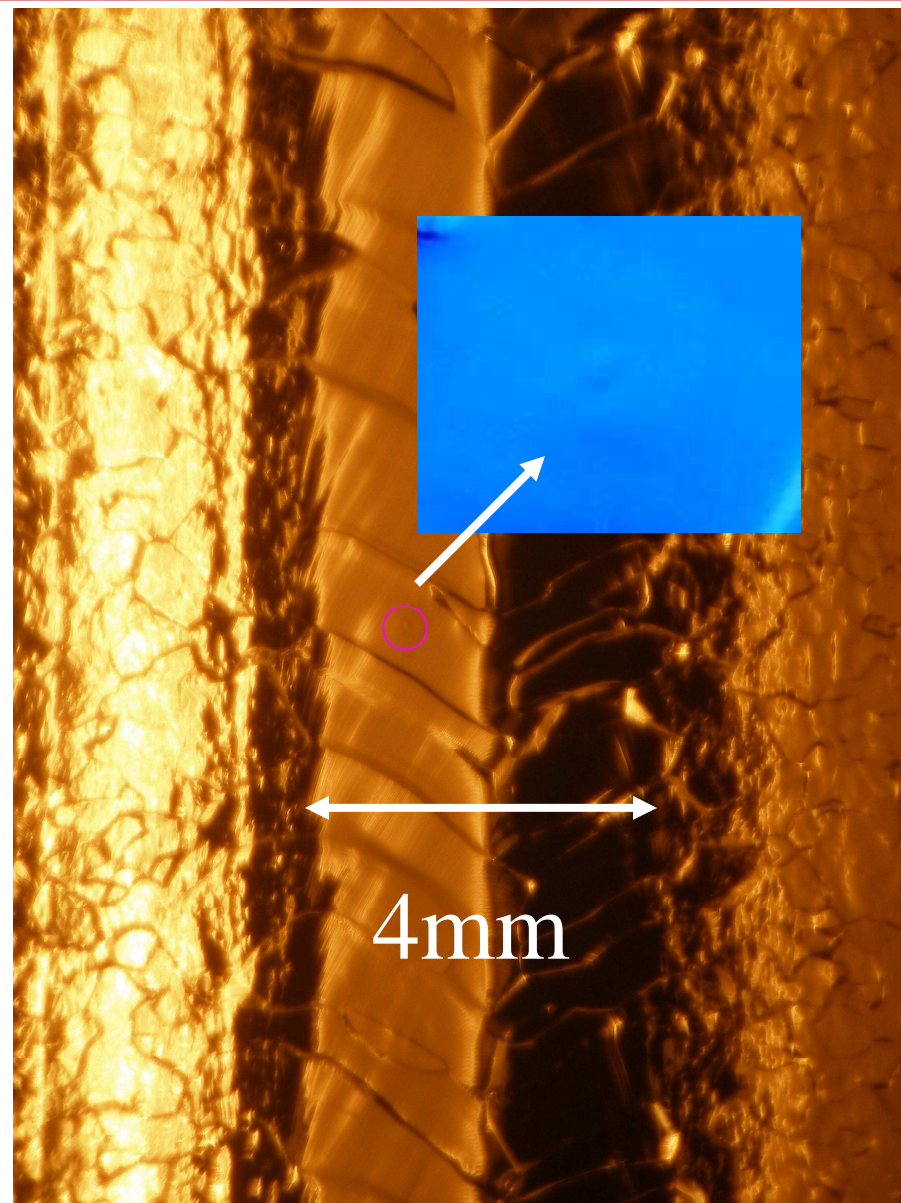
Equator EBW Defects

- Weld defects encountered.
 - Bumps/Pits
 - Deformed Welds
 - Trenches
 - Nothing visible optically at all...
- First, a look at bumps/pits (~38% of defects found).

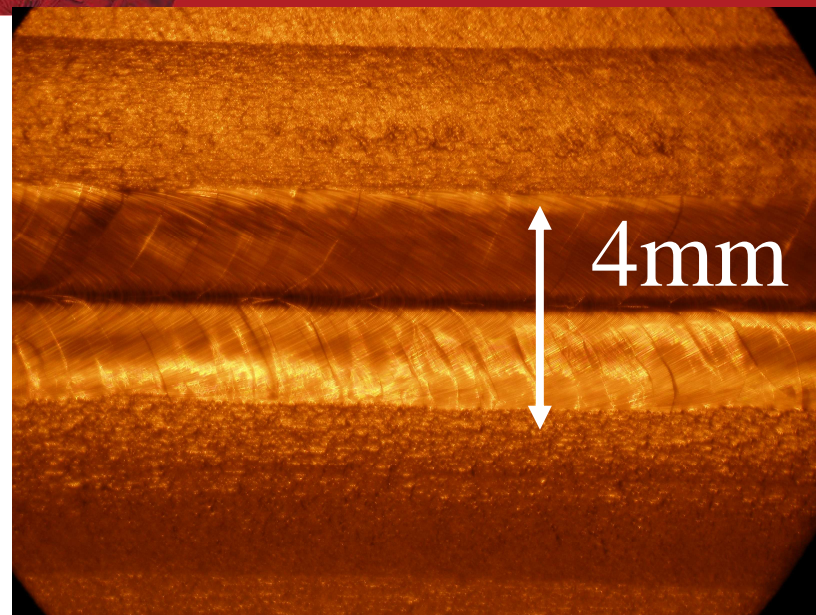
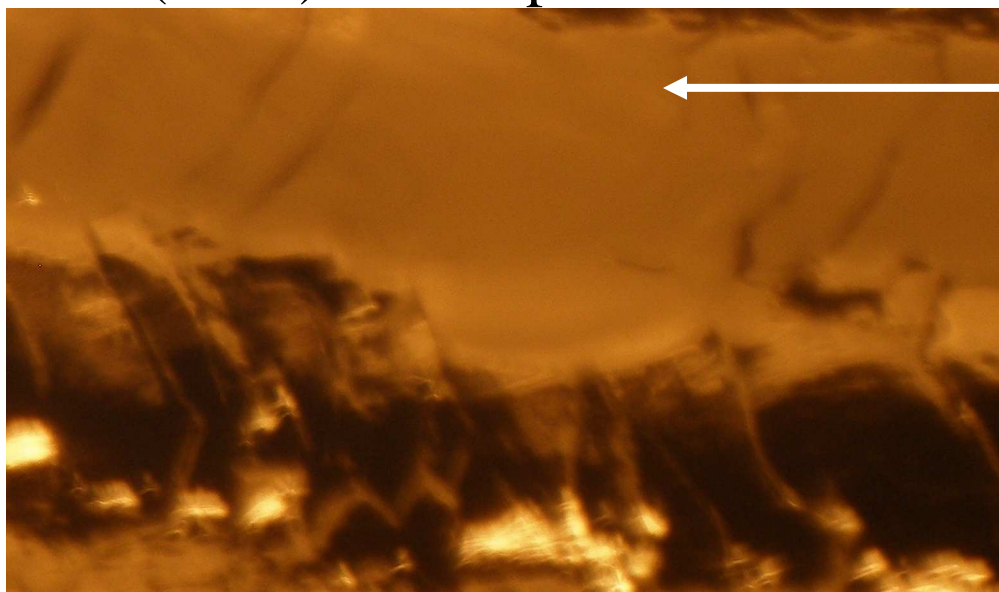
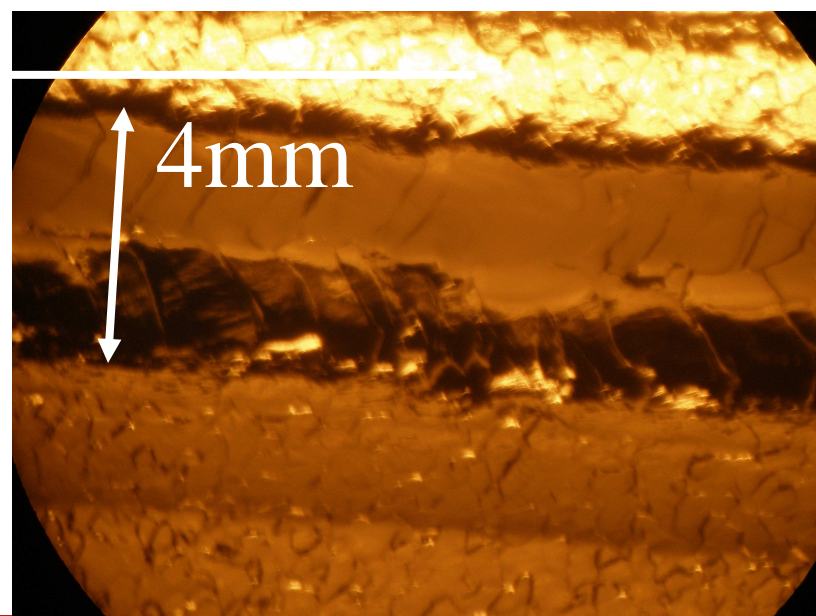
Equator EBW Defects

- Deformed welds (25%)
- Cause unknown?
- The outside weld looks perfect.
- The entire circumference of the inside weld before BCP (1:1:2) looked perfect.

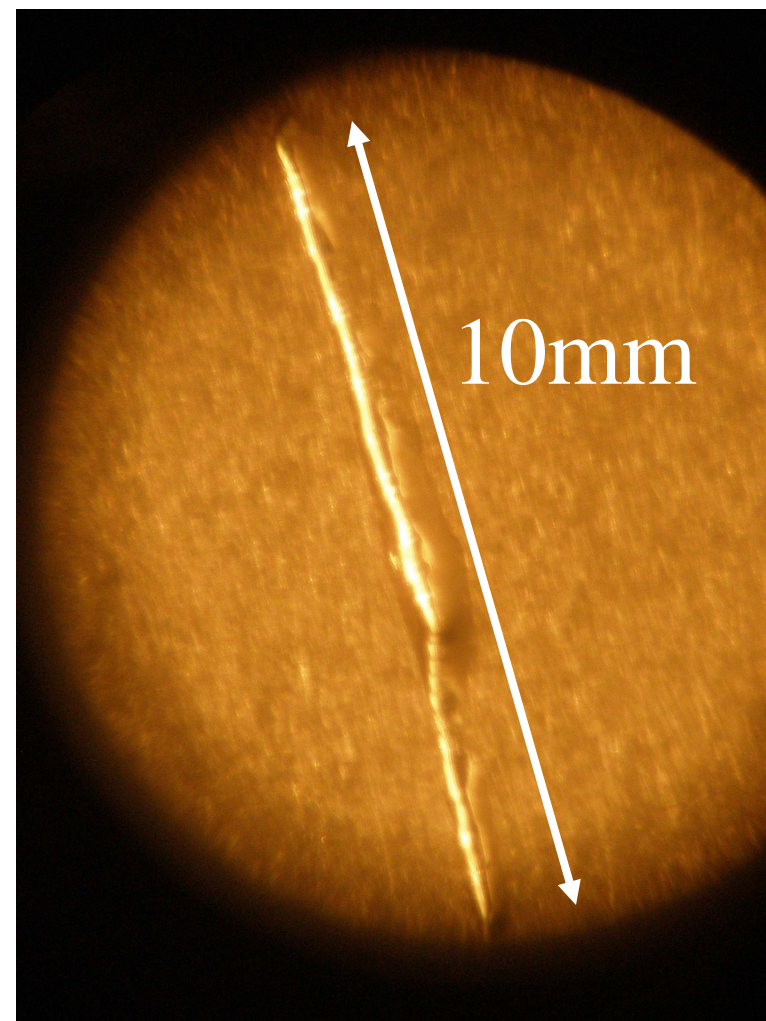
Equator EBW Defects

- Trenches in equator EBW (25%).
- Due to faulty EBW welding.
- Picture on right is after tumbling. Improved contrast of trench.
- This trench is located at the EBW overlap.
- EP and BCP do not remove these defects. Tumbling or local grinding required.

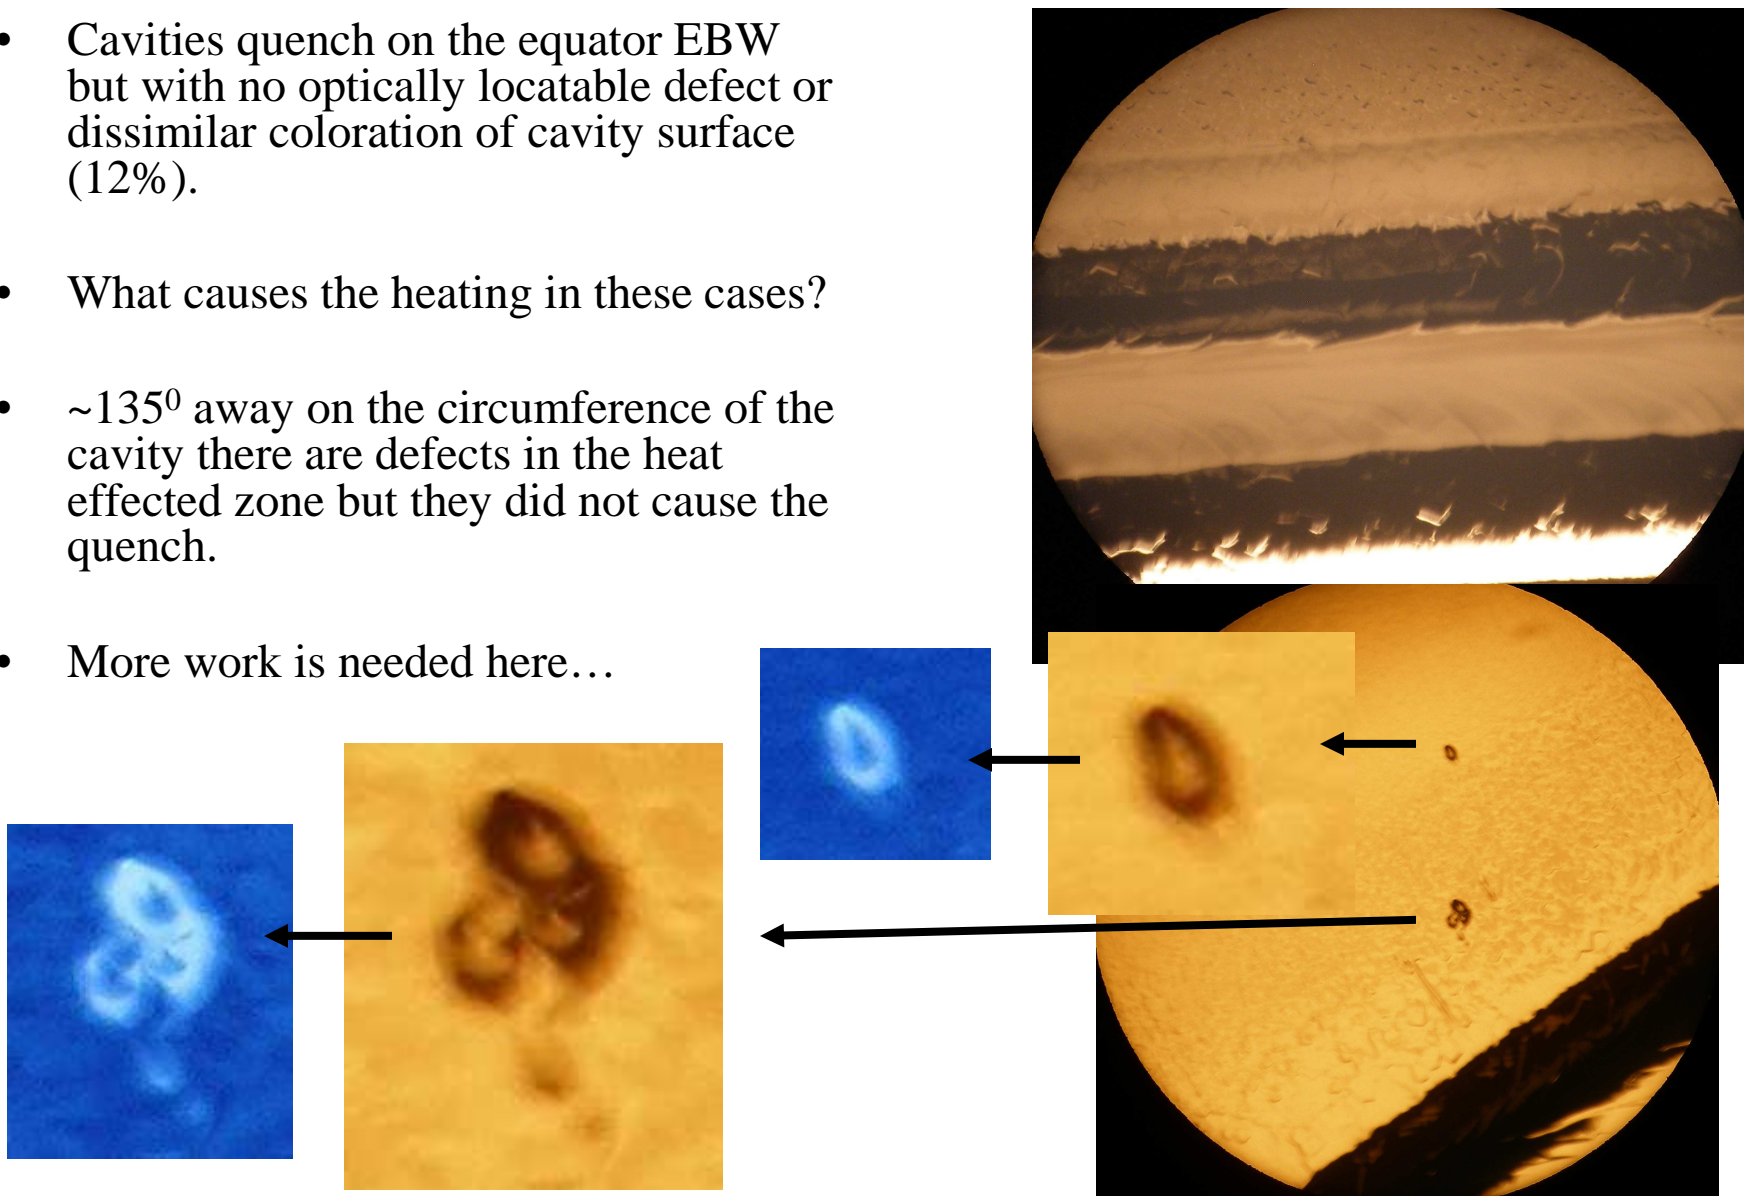
Equator Weld Defects

- Cavities quench on the equator EBW but with no optically locatable defect or dissimilar coloration of cavity surface (12%).
- What causes the heating in these cases?
- $\sim 135^\circ$ away on the circumference of the cavity there are defects in the heat effected zone but they did not cause the quench.
- More work is needed here...

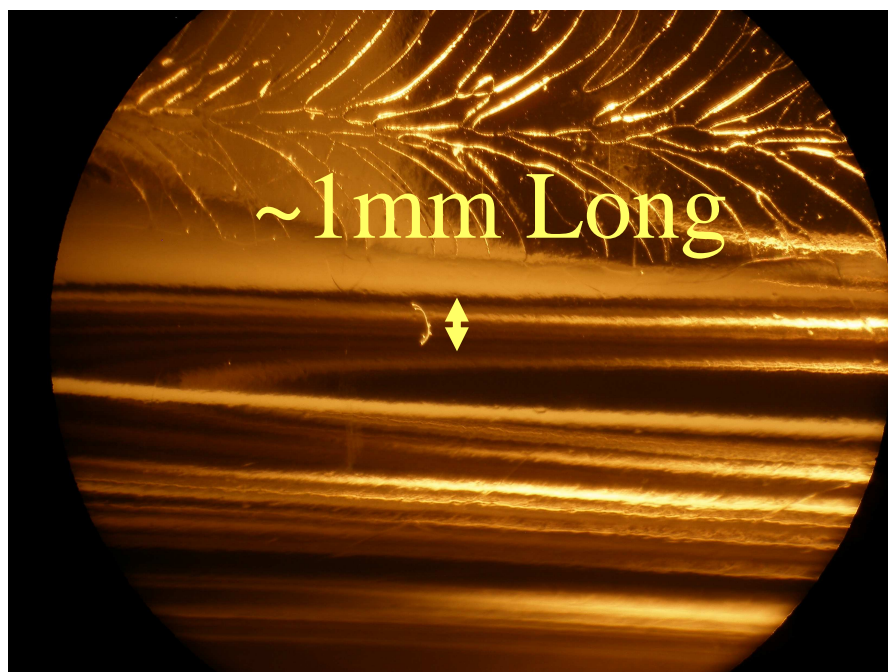
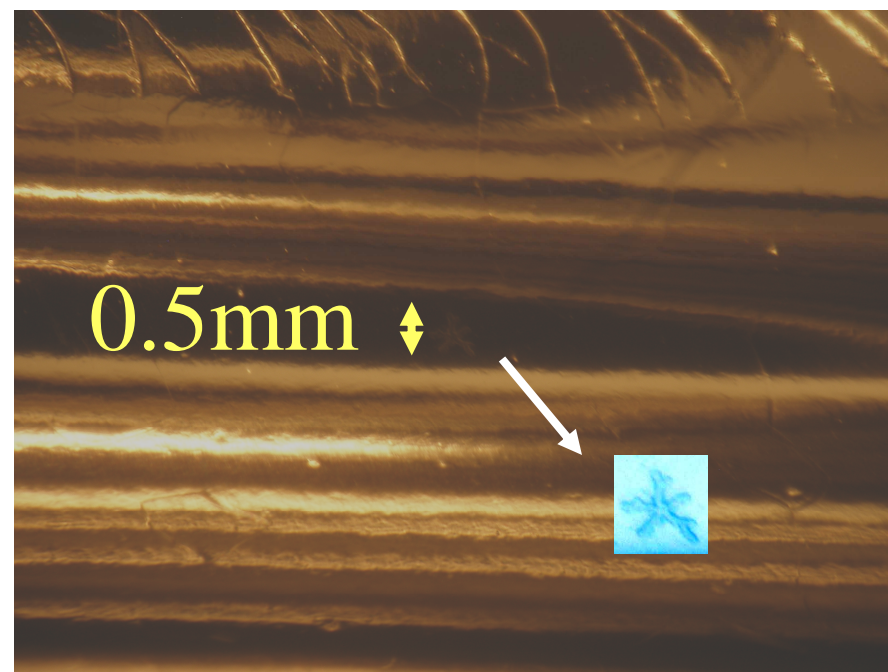
Iris Defects

- Iris defects are located indirectly.
- Cavity heating due to field emission is detected.
- One must work their way back up to the iris to find the defects.
